BOEING VERTOL CO PHILADELPHIA PA  
SMALL HARDWARE DESIGN FOR EASE OF MAINTENANCE AND INSPECTION.(U)  
MAR 77 L D BARRETT  
D210-11081-1

**SMALL HARDWARE DESIGN FOR EASE OF  
AND INSPECTION**

Boeing Vertol Company  
P.O. Box 16858  
Philadelphia, Penn. 19142

March 1977

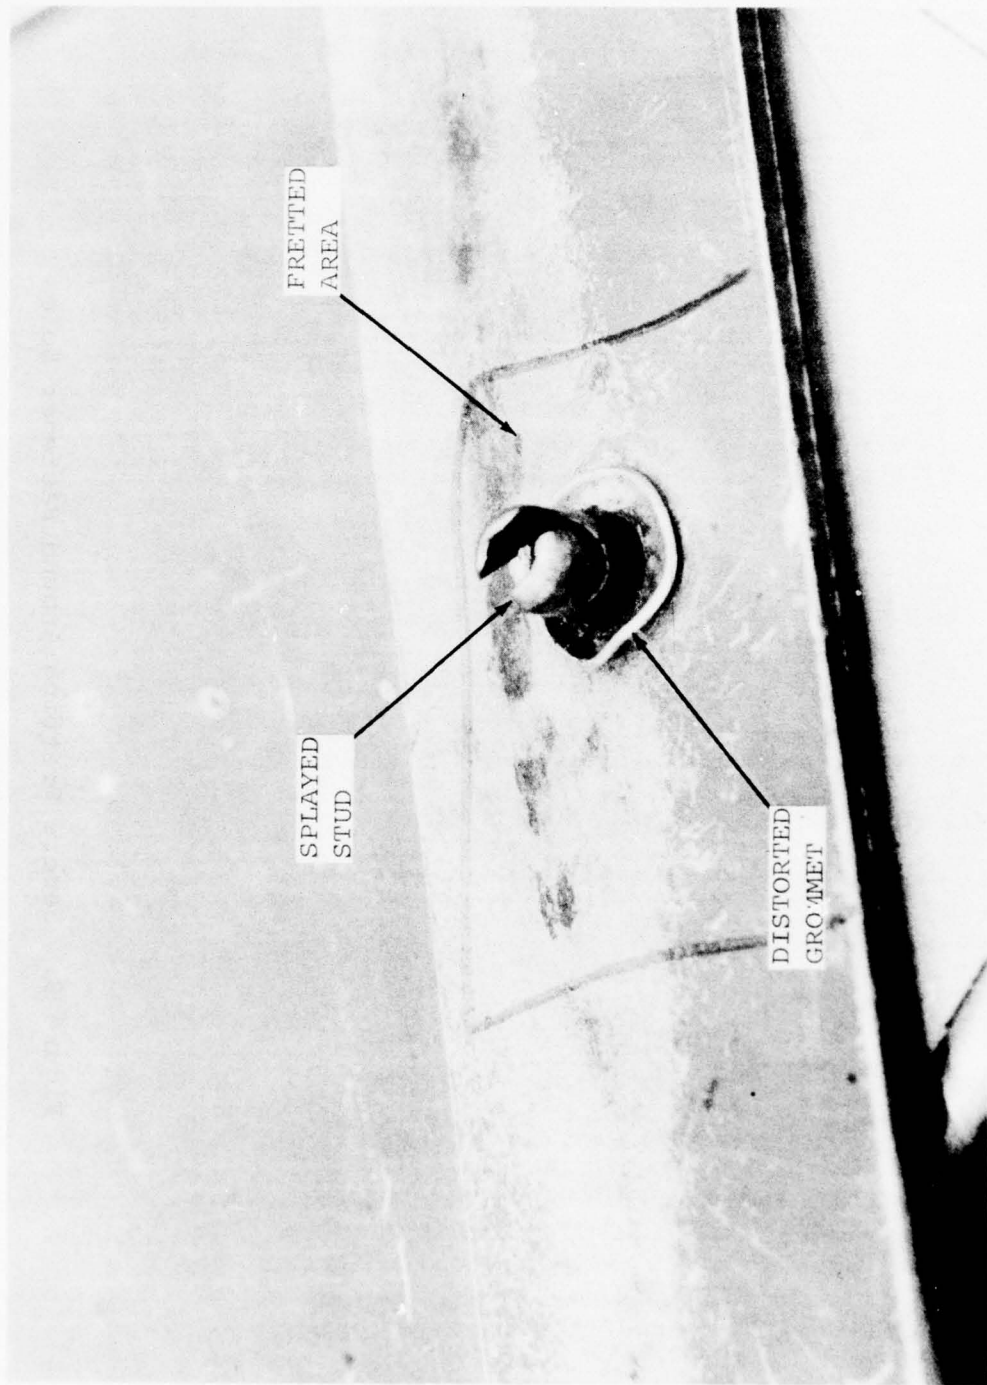
Figure 7. Distorted Stud-Retaining Grommet and Splayed Stud

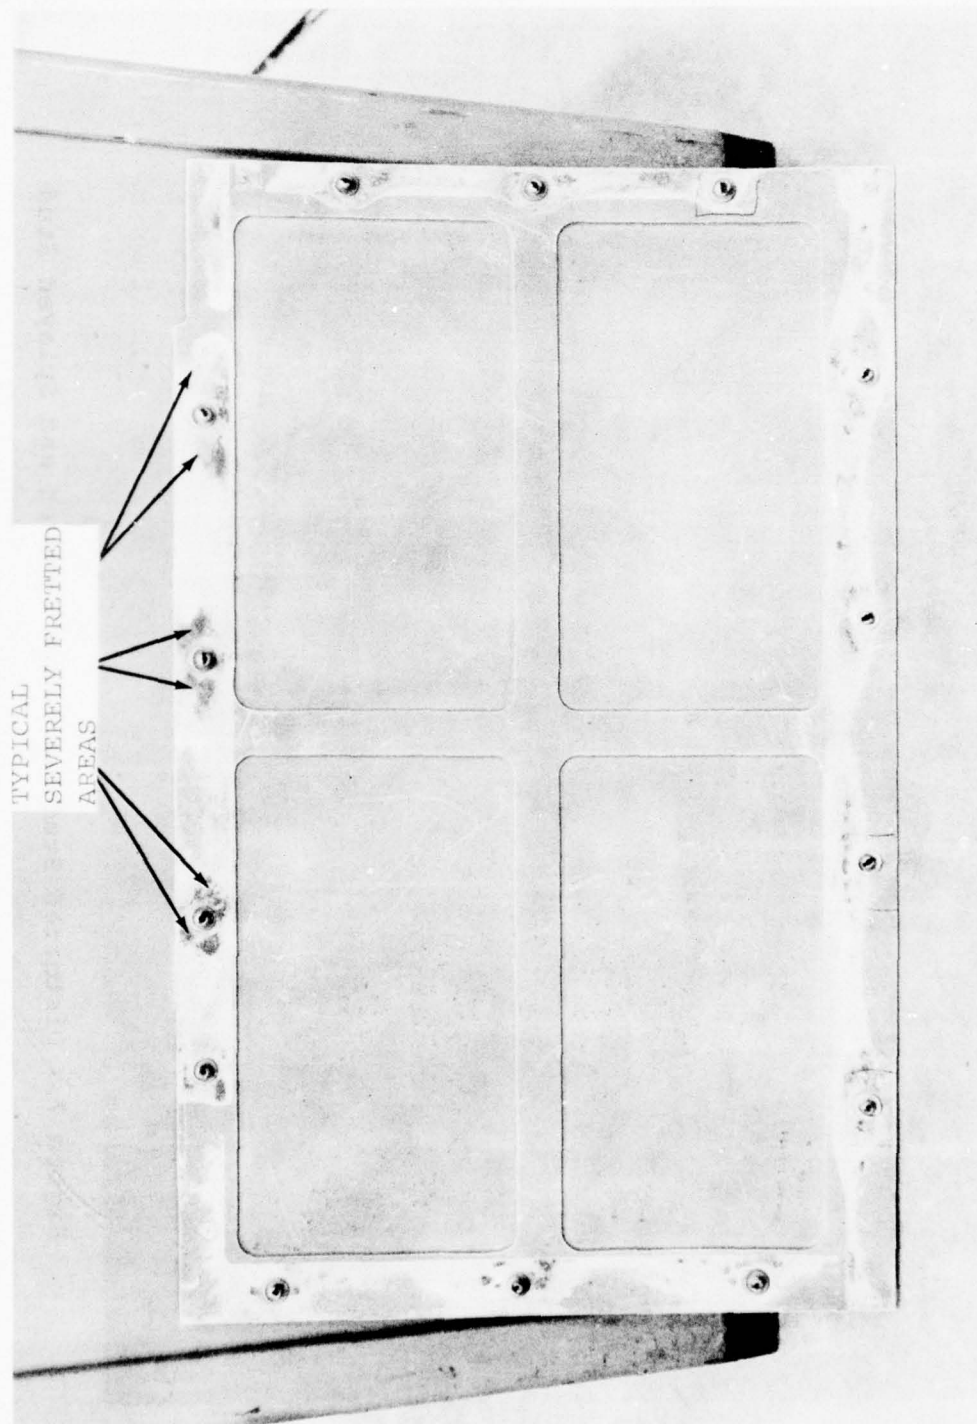
1. Frequency of utilization - daily inspection of flight controls necessitates frequent operation of the fasteners.
2. Vibration - the high vibration environment causes constant cycling of the panel in the panel's surroundings, and severe fretting around the fastener holes frequently occurs as shown in Figure 8.

Figure 8. Severe Fretting Around Fastener Holes

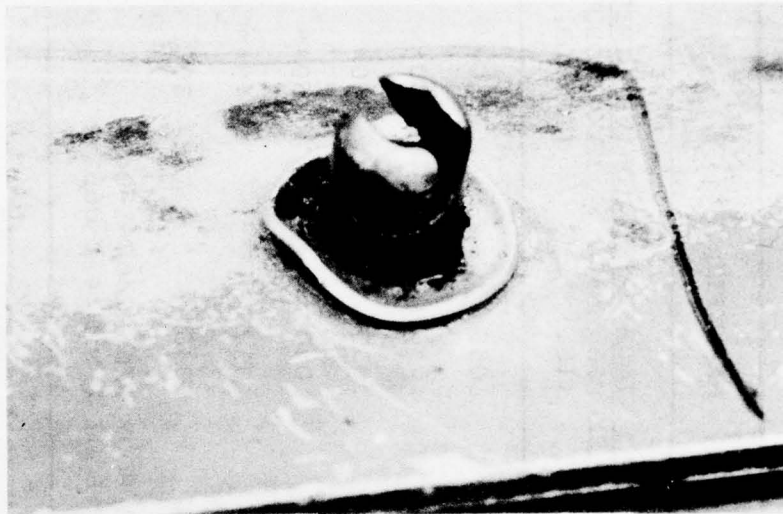
Figure 13. Deformed Dzus Retaining Washer

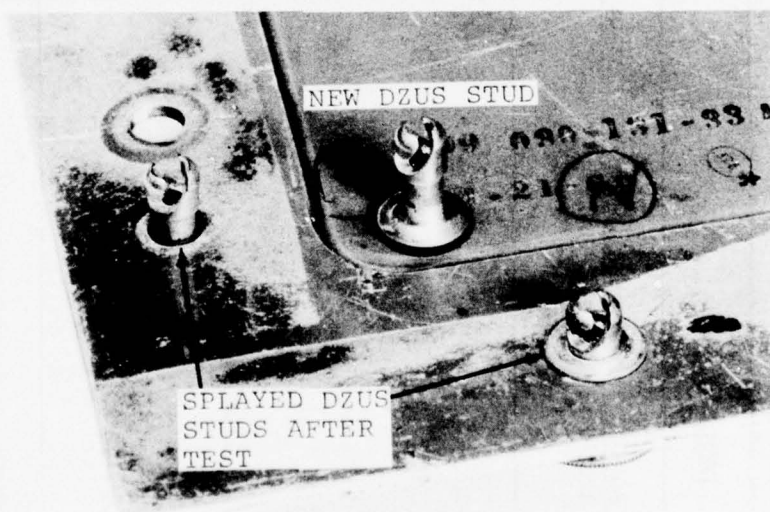
Figure 14. Splayed Fastener From Over-Grip Test

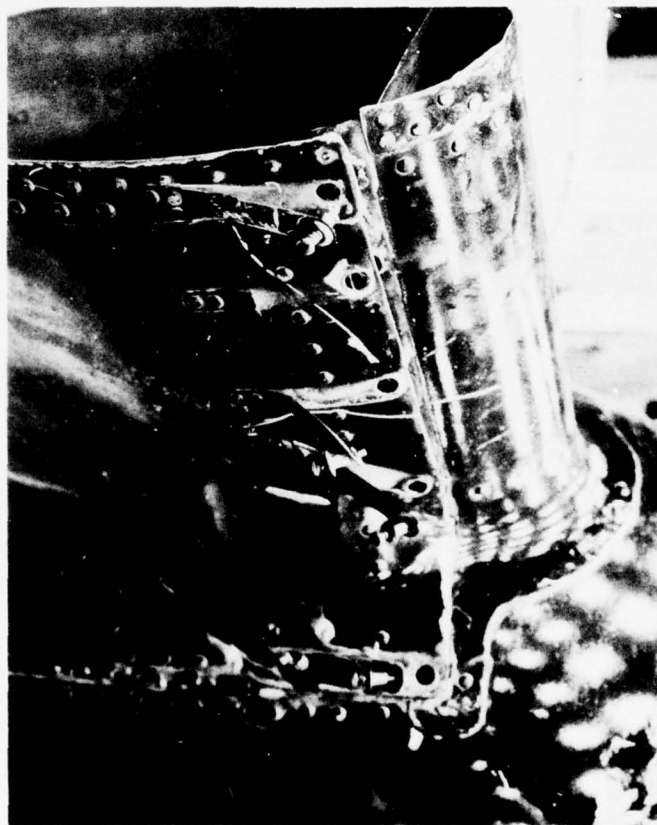
Figure 17. Chafed Fairing Edges From In-Service Vibration

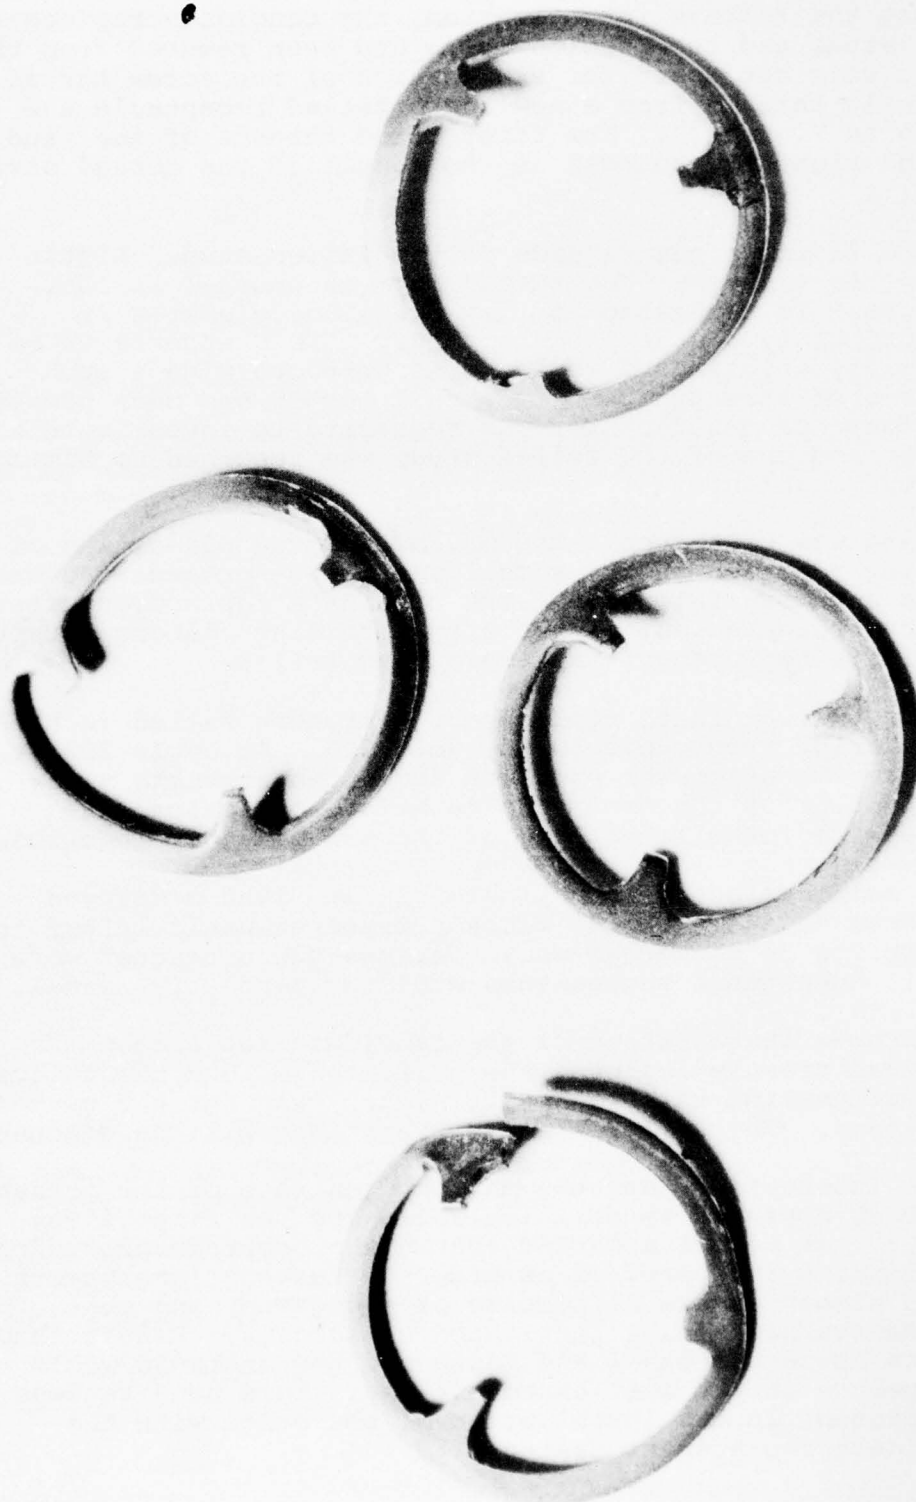
Figure 19. Candidate Replacement Stud Retaining Washer Failure

The reason for the failure of the stud retaining washer for the candidate replacement fastener could not be determined. Two factors appeared to be involved.

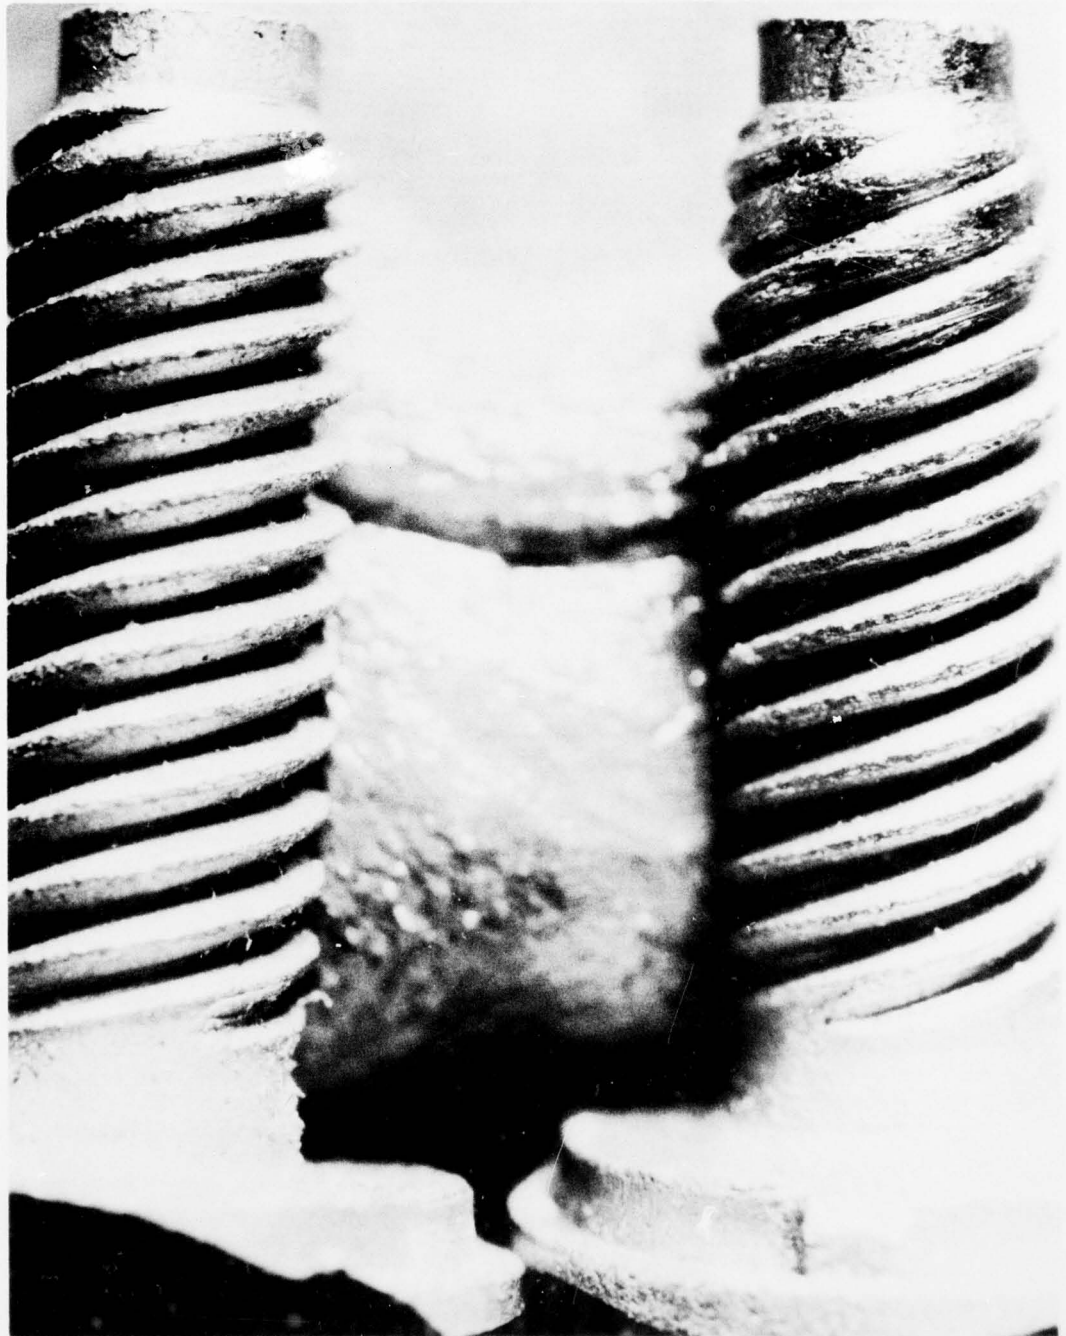
Figure 20. Failed Screw From Receptacle on Right

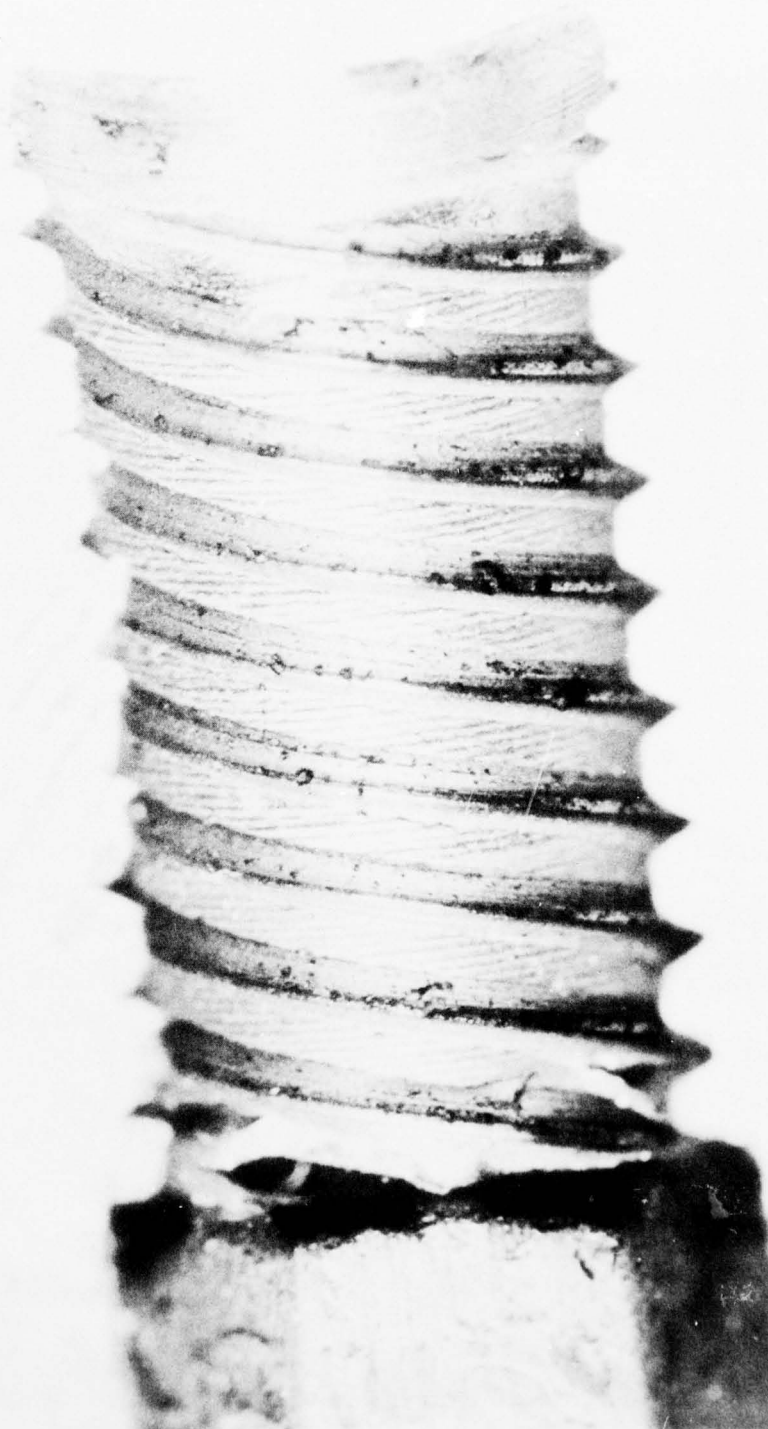
Figure 21. Truncated Thread Form From Failed Stud

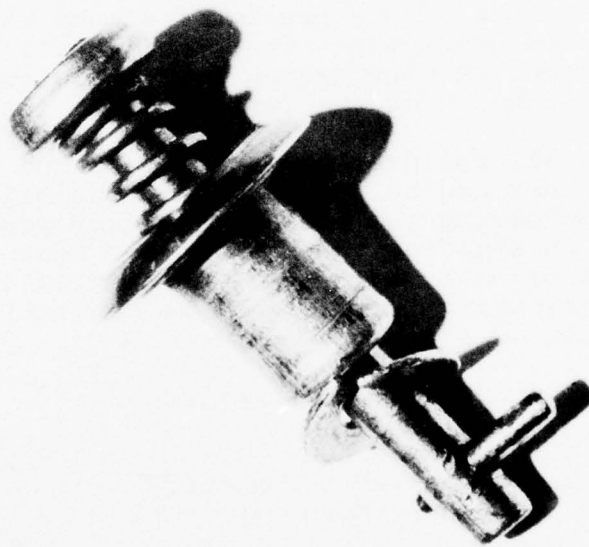
Figure 22. Present fastener "after" cross pin caused by the Endurance Test

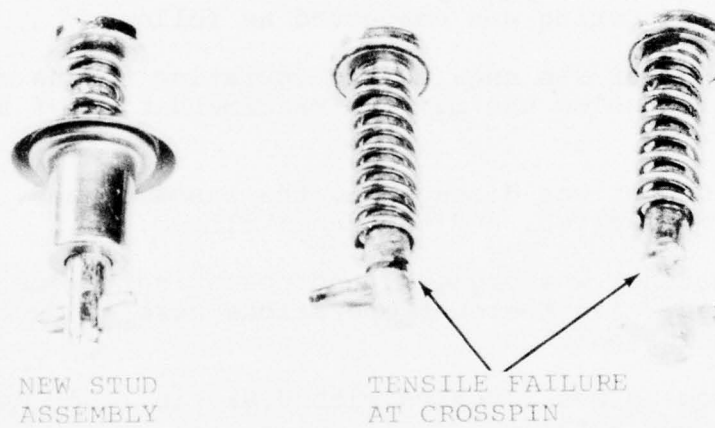
- The present fastener failed at grip lengths ranging from 0.026 to 0.039 in. above the manufacturer's recommended maximum. Maximum torques at failure ranged from 35 to 50 in.-lb. Three of the studs broke at the cross-pin attachment (Figure 25). The other three failed by the cam-out of the screwdriver slot in the head.

Figure 25. Failed Stud at Cross Pin

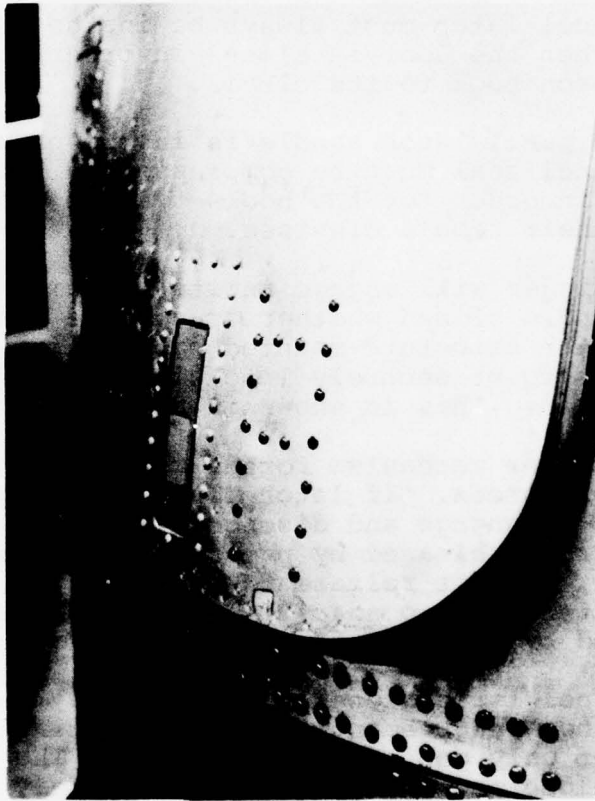
A deflection test was run to verify and document the reported panel mounting flexibility. The door proved very flexible. A 4-lb sideways force was enough to prevent the latch hooks from engaging. The spring rate was 16 lb per in. The panel spring rate was even lower for a

Figure 36. Present Latch Handle is Latched but Door is Open

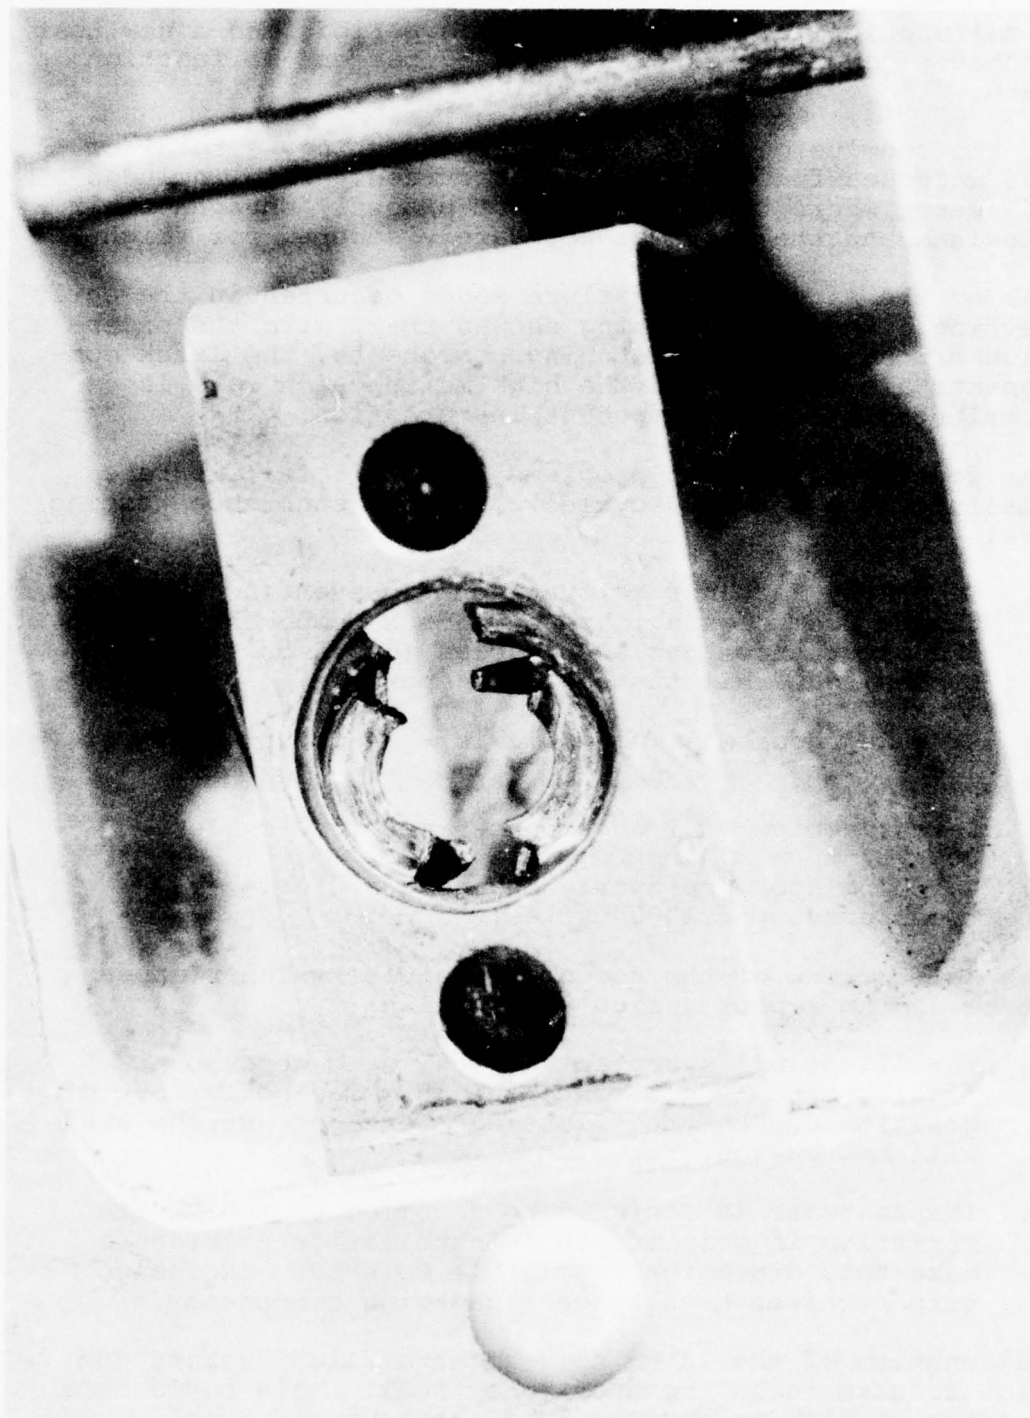
Figure 38. The Failure of the Receptacle of a Secondary Handle Lock

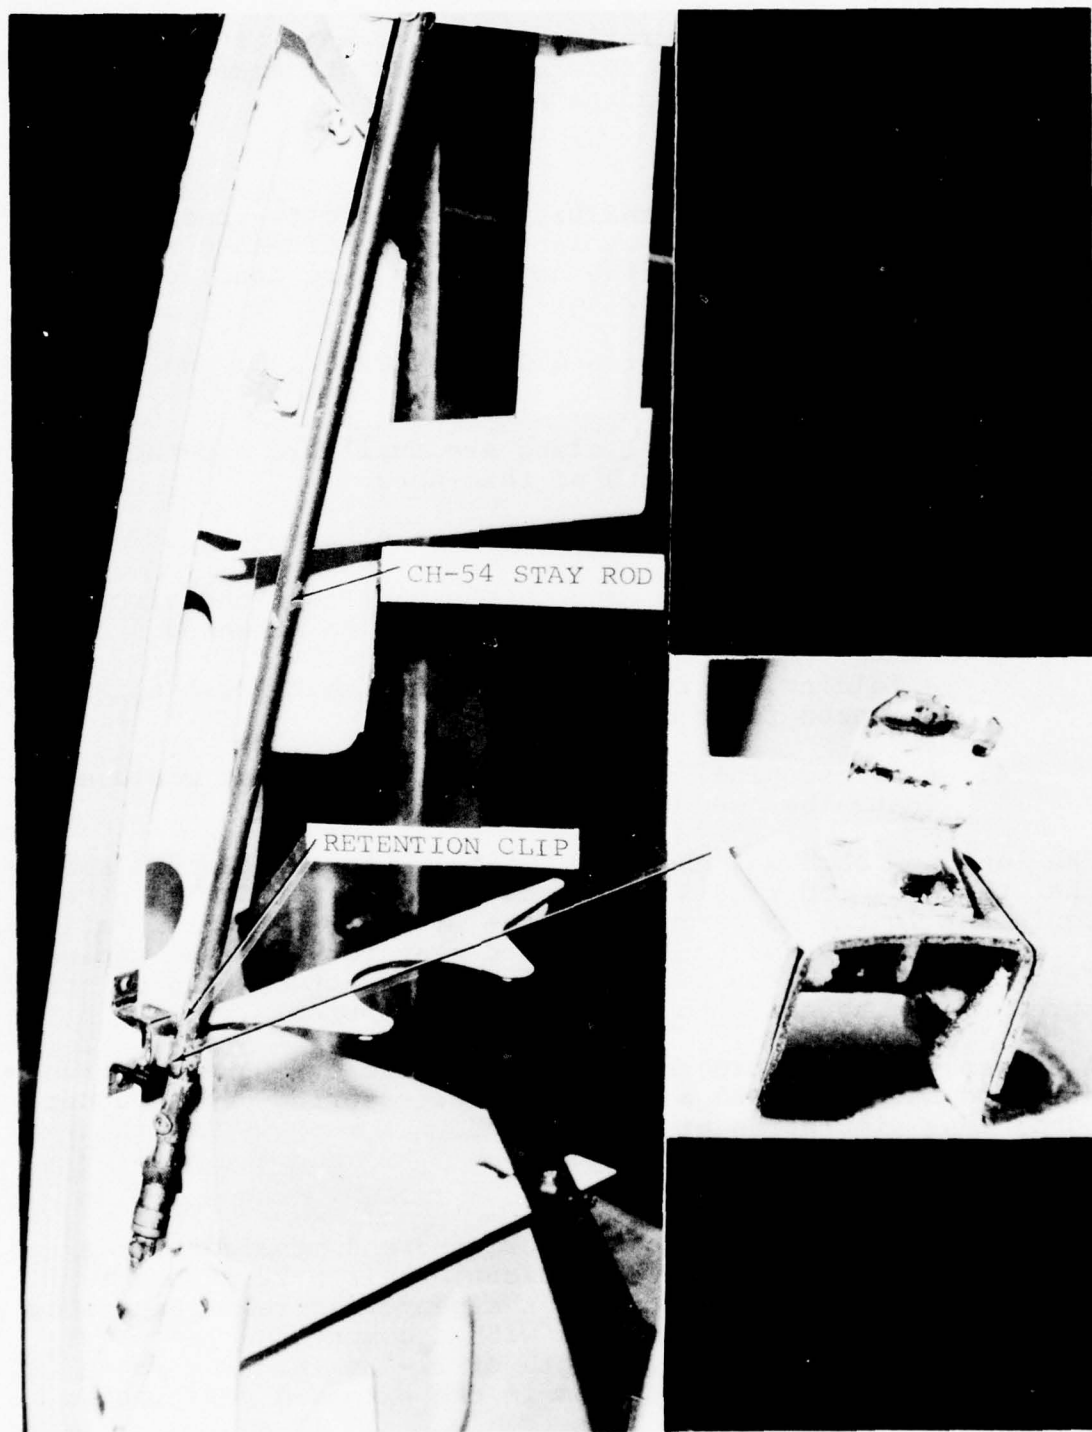
Figure 41. Test Installation--CH-54 Stay Rod, Retention Clip, and Typical Failed Clip

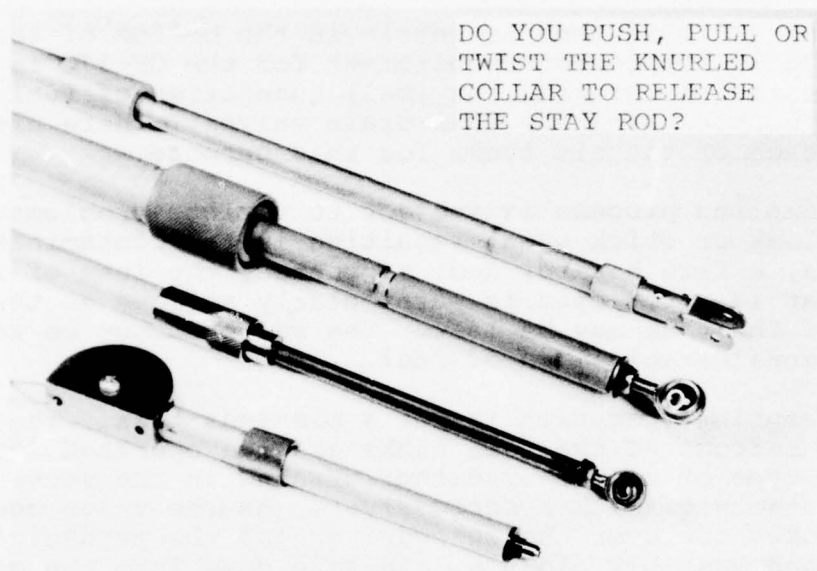
Figure 44. Stowable Stay Rods Whose Operating Procedures Are Vague

However, all factors considered, it appears that for most installations of Army helicopters the alternative design approach tested herein or a similar type of self-stowing device should be specified for new production aircraft.

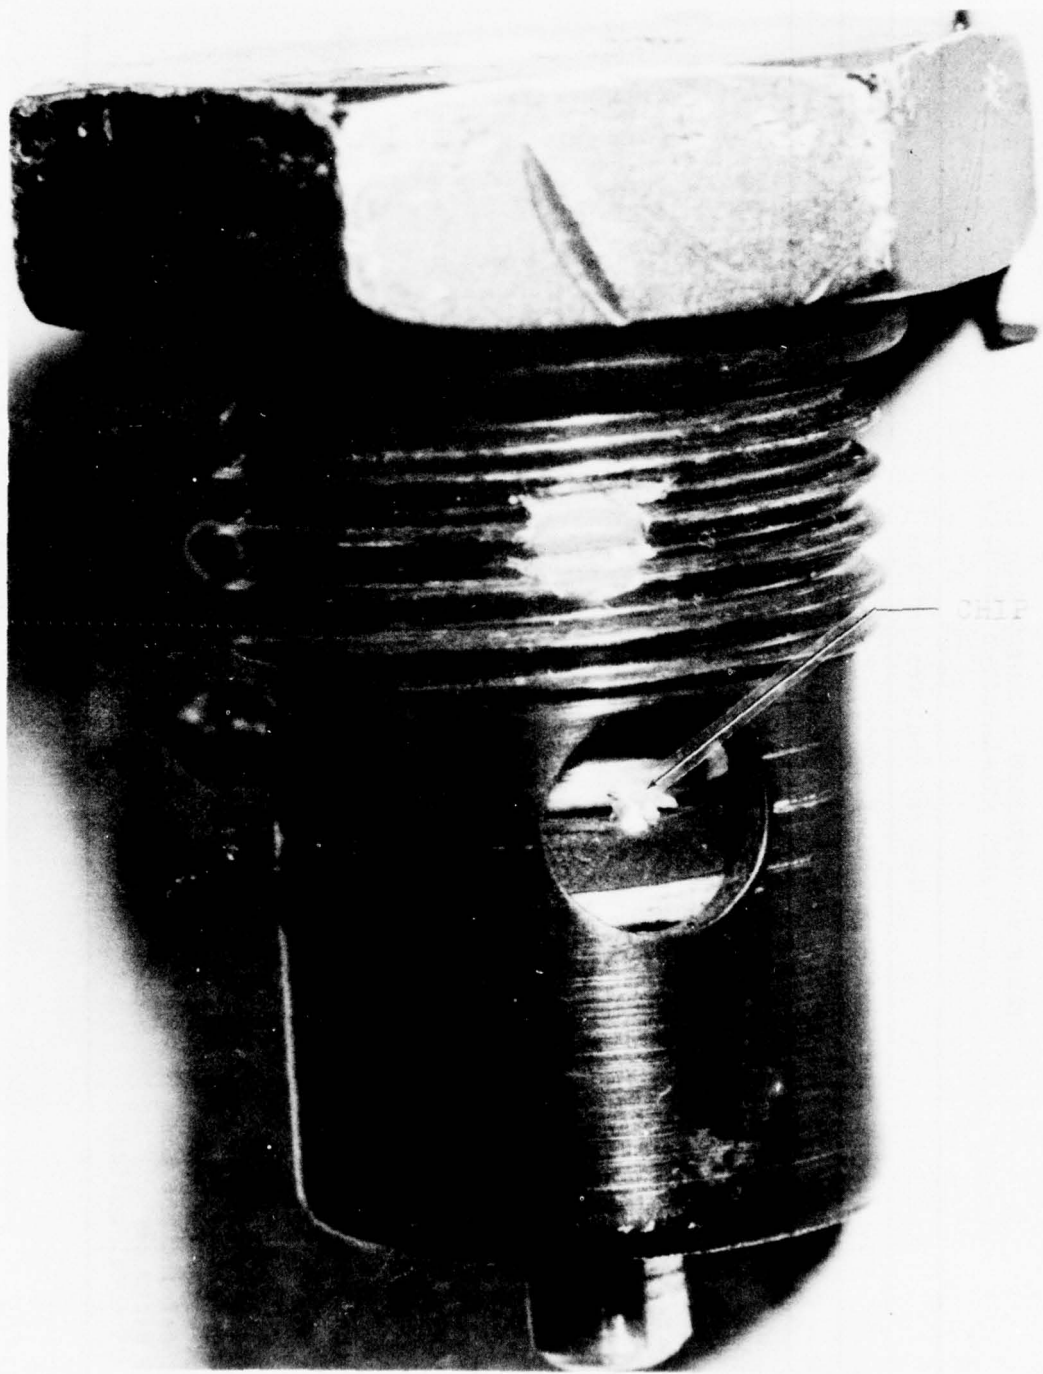
Figure 45. Baseline Valve With Chip Embedded in Elastomeric Seal

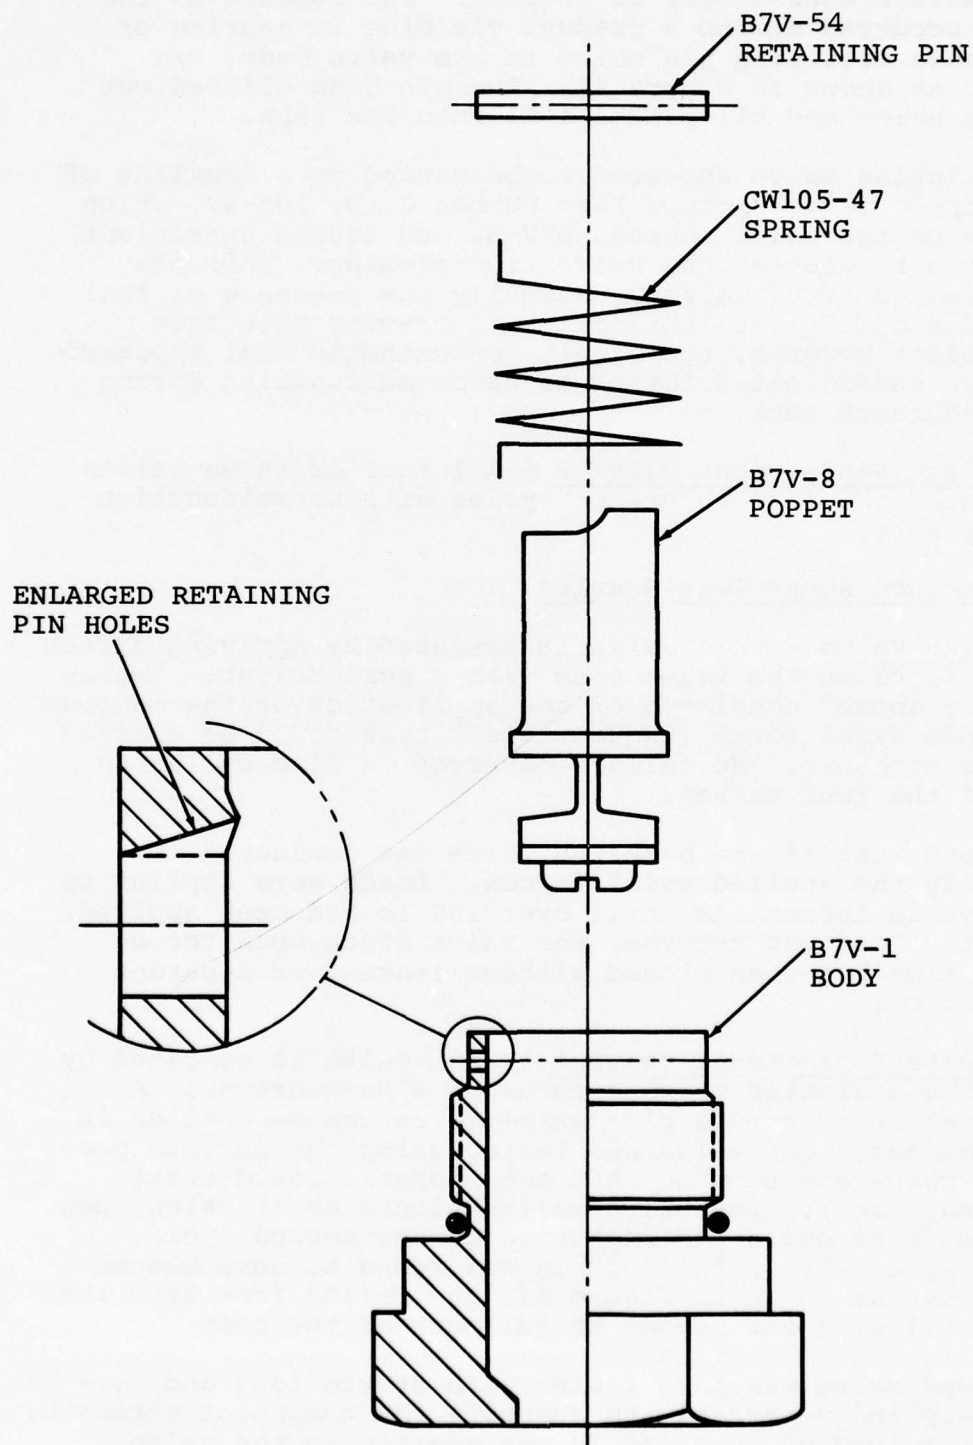
Figure 46. Endurance Test Failure of Candidate Replacement Valve 1 due to the Loss of the Retaining Pin

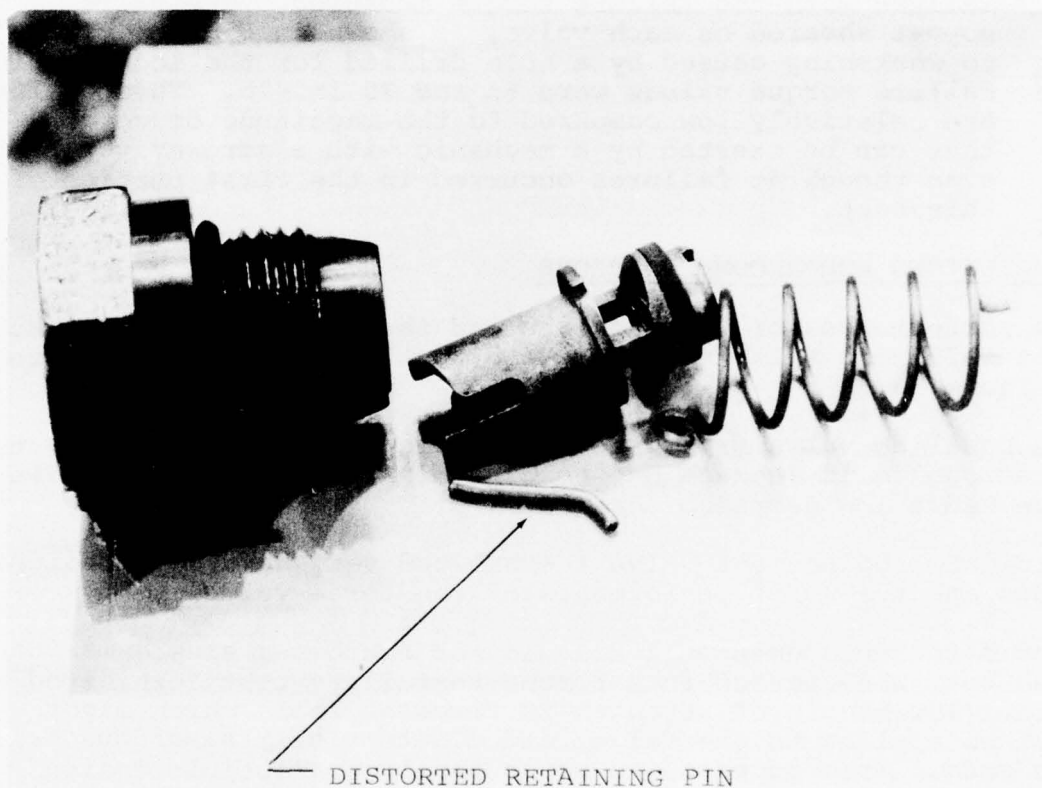
Figure 47. Candidate Replacement Valve 1--Failure in Maintenance Abuse Test

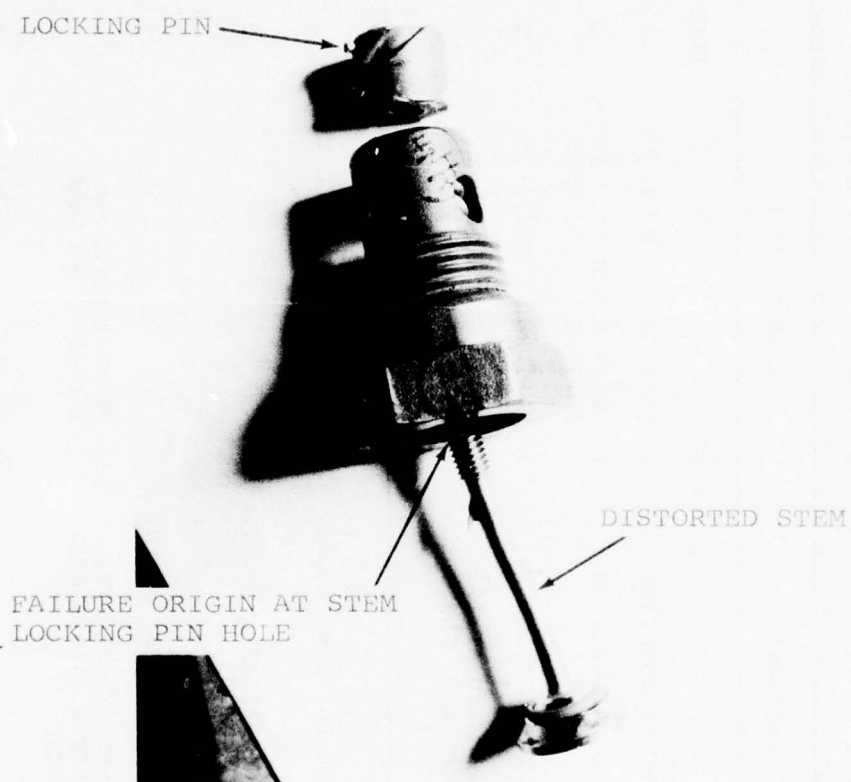
Figure 48. Candidate Replacement Valve 2--Failure During Maintenance Abuse Test

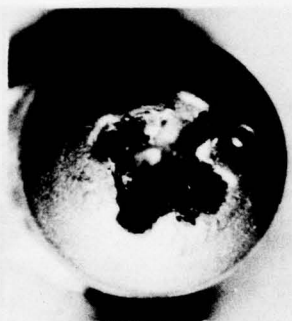
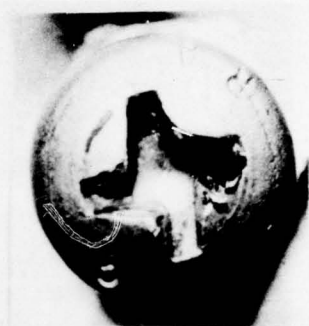
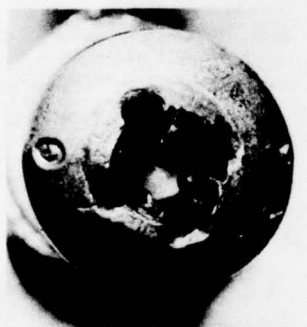
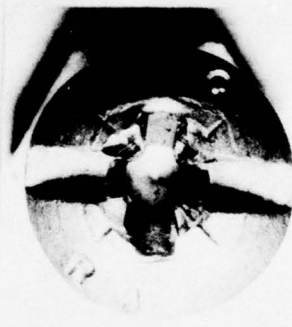
- Self-locking nuts with high friction torques are responsible for much of the head recess damage. The screwdriver will cam-out of the slot if misaligned at any time while tightening or loosening unless a substantial axial force is applied. Use of a self-locking nut requires nearly constant axial force on

Figure B-5. Recess Damage From Screwdriver Cam-Out

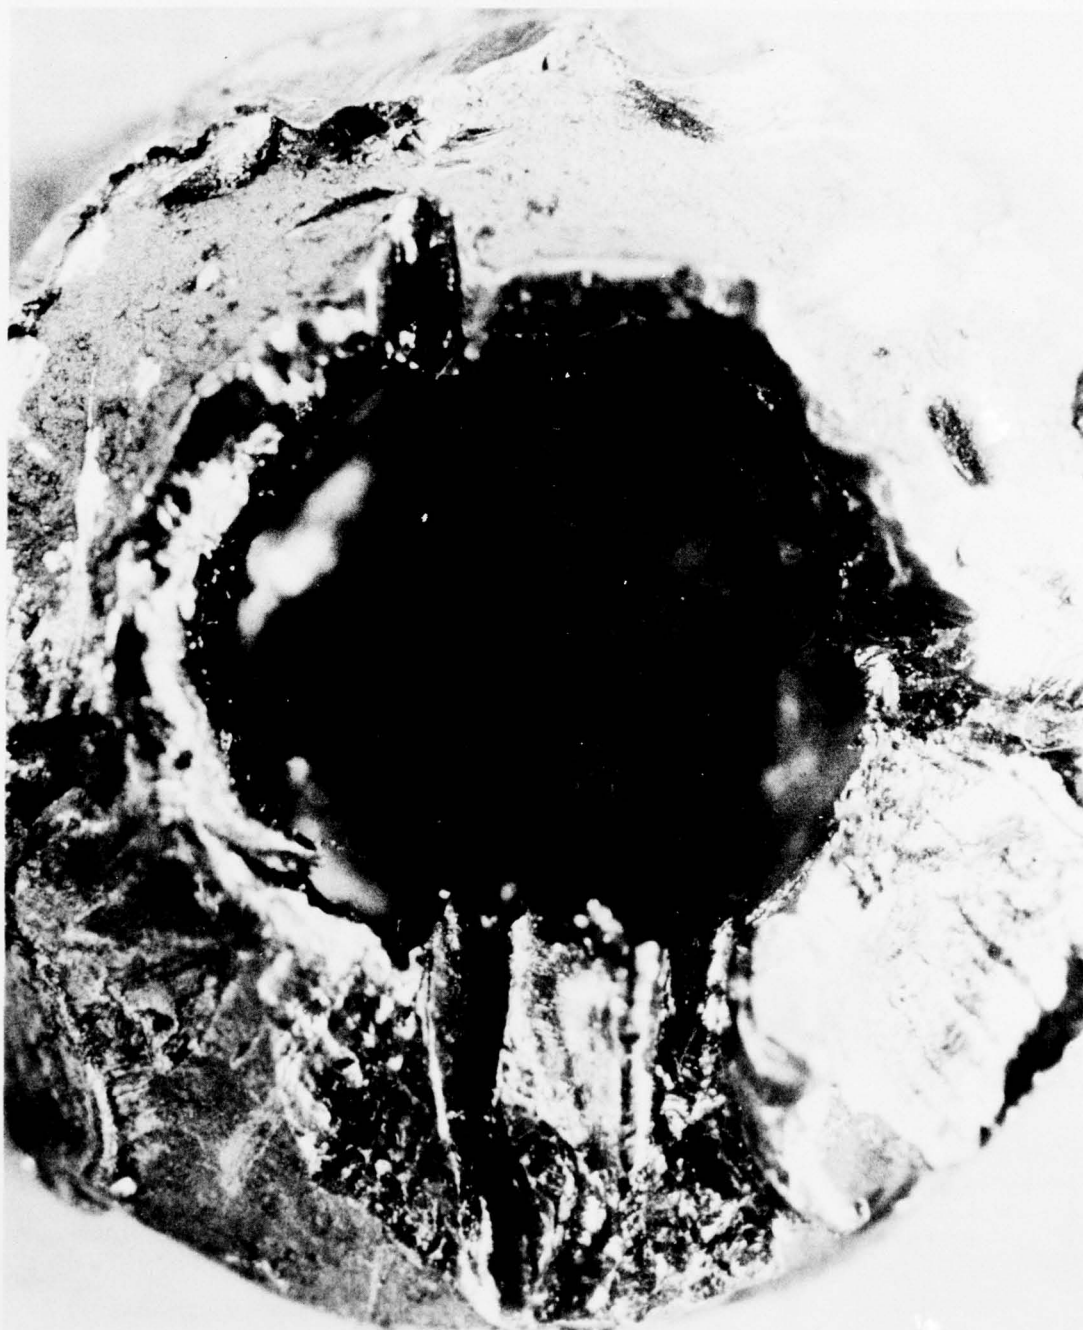
Figure B-6. Problems With Screw Removal After Recess Failure

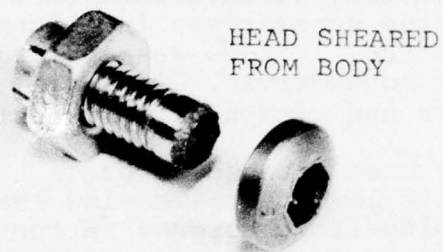
HEAD SHEARED  
FROM BODY

Figure B-8. Allen Head Tension Failure

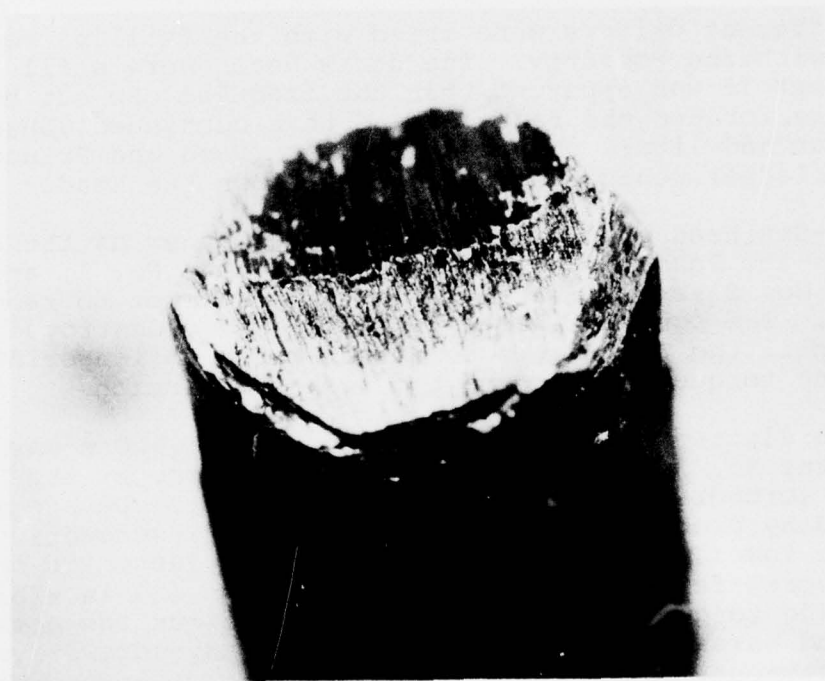
Figure B-10. Worn Allen Key
